Shoreline Situation Report ISLE OF WIGHT COUNTY, VIRGINIA

Chesapeake Research Consortium Report Number 46

Special Report In Applied Marine Science and Ocean Engineering Number 97 of the

1975

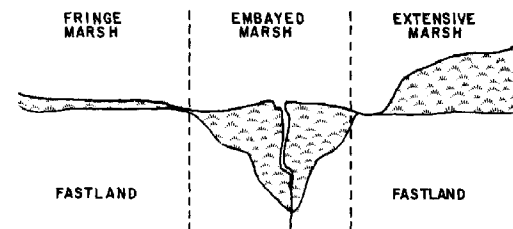
Figure 2 A generalized illustration of the three different marsh types.

The physiographic character of the marshes has also been separated into three types (see Figure 2). Fringe marsh is that which is less than 400 feet in width and which runs in a band parallel to the

shore. Extensive marsh is that which has extensive acreage projecting into an estuary or river. An embayed marsh is a marsh which occupies a reentrant or drowned creek valley. The purpose in delineating these marsh types is that the effectiveness of the various functions of the marsh will, in part, be determined by type of exposure to the estuarine system. A fringe marsh may, for example, have maximum value as a buffer to wave erosion of the fastland. An extensive marsh, on the other hand, is likely a more efficient transporter of detritus and other food chain materials due to its greater drainage density than an embayed marsh. The central point is that planners, in the light of ongoing and future research, will desire to weight various functions of marshes and the physiographic delineation aids their decision making by denoting where the various types exist.

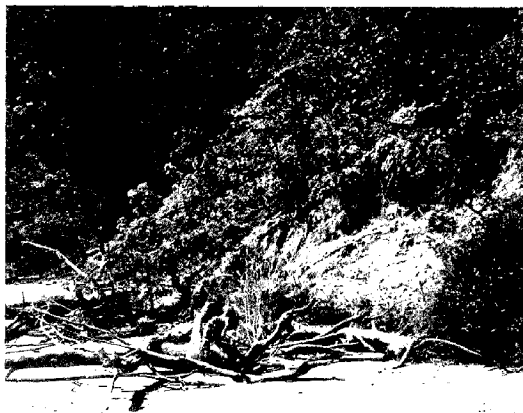
FIGURE 3

Figure 3: Eroding bluffs at Lawmes Neck. The falling trees uproot large amounts of soil, further adding to the erosion problem.

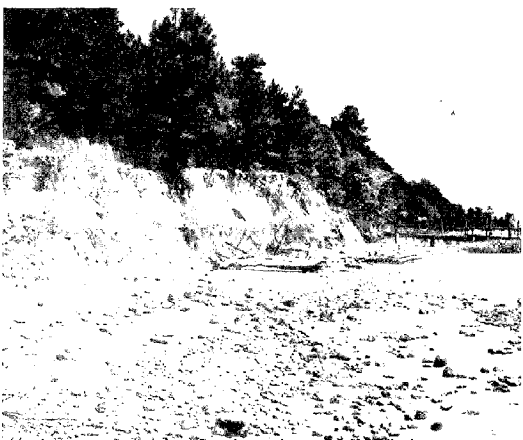
FIGURE 6

Figure 6: Eroding bluffs just north of previous photo. The beach and lower half of the bluffs are mostly clay and are not suitable for most recreational activities. When the Reserve Fleet extended south this far, the area was mostly stable. Without that offshore protection, erosion is again a problem.

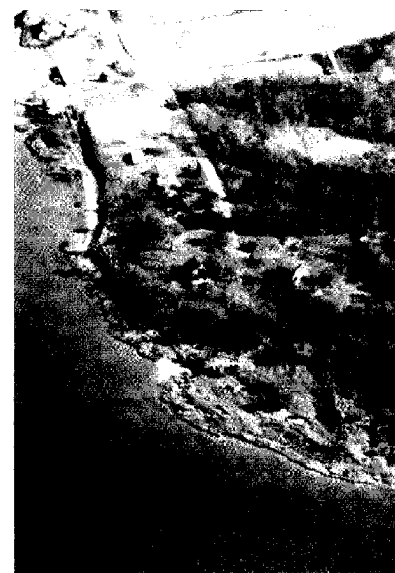
FIGURE 7

Figure 7: An aerial view of Goodwin Point. Parts of the shoreline have been bulkheaded, but unprotected stretches are very vulnerable to wind and wave attacks.

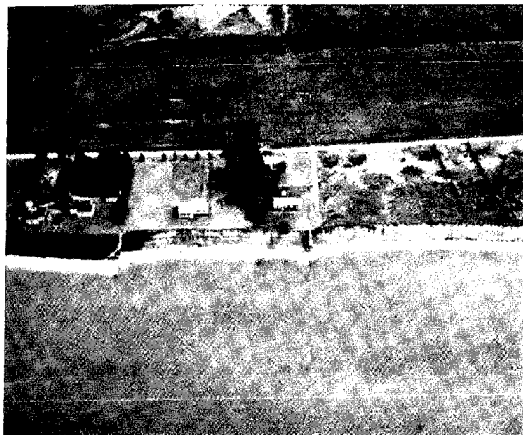
FIGURE 8

Figure 8: Aerial view of Mogarts Beach. This area had an erosion rate of 3.8 feet per year until the Reserve Fleet was anchored to the north. Although erosion is still a problem in some areas, it is not as severe.

effectively cut off the long fetch to the north-northwest, protecting the shoreline from severe storm effects. Along Mogarts Beach, the once eroding 30-foot high bluffs are now covered with vegetation (Figure 9). However, this condition of stability probably will be short lived, for the Reserve Fleet is being constantly diminished in numbers. This was the case at Rushmere Shores. When the Fleet was offshore, the area stabilized and a beach developed. Since the Fleet has been moved from offshore, the area has again been suffering from erosion (Figure 6). When the Reserve Fleet is no longer interrupting the long north-west fetch to Mogarts Beach, the area will once again suffer from the effects of the severe north-western storms.

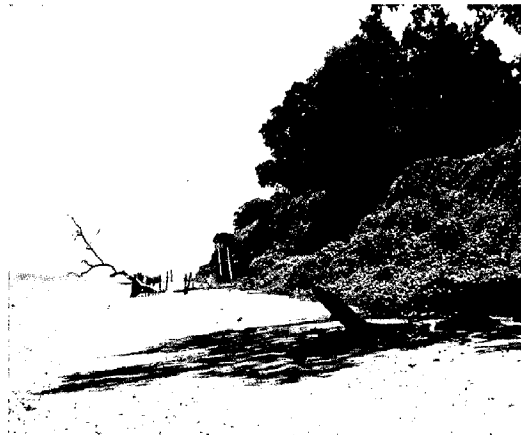
FIGURE 9

Figure 9: Ground view of Mogarts Beach. The tree on the beach gives evidence of past erosion. The bluffs should be graded and revegetated if they are to withstand wind and wave attacks.

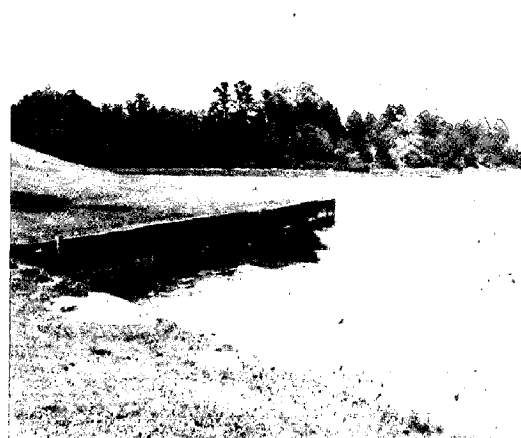
FIGURE 11

Figure 11: Wooden bulkhead near the mouth of Brewers Creek. The structure is in very good shape and is retaining fill in front of several residences.

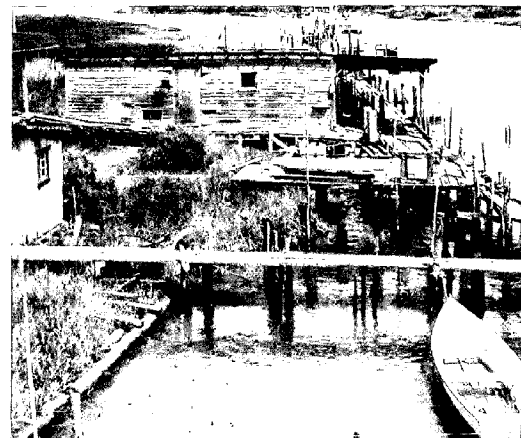
FIGURE 12

Figure 12: View at bridge along Jones Creek. The logs lying in front of the marsh act as a buffer against boat wake erosion in this low intensity area. A marina is directly across the creek.

Along the creeks, where boat wakes are the major erosion cause, some type of protection in front of affected marsh areas may be necessary. In one place, logs have been staked in front of the marsh to cut down on the wave energy reaching the grasses. Such devices can sometimes achieve the desired effect in low intensity areas. Speed limits for boats traveling in the creeks should be enforced.
